# Skaneateles Lake Watershed Composting Toilet Project

Rich Abbott

## Abstract:

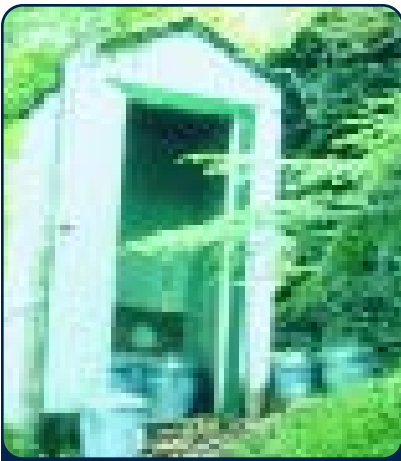
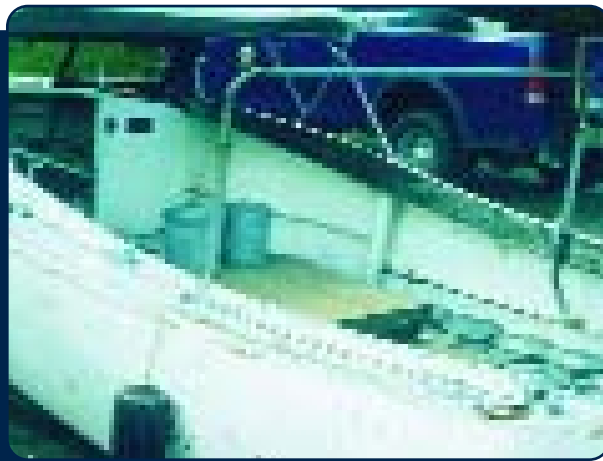
Prior to the composting toilet project, many lakeside residents in Skaneateles relied on a pail pick-up service initiated in 1908 to dispose of their household sewage. Five-gallon pails of raw sewage were transported by truck and boat to Syracuse. Photos by Rich Abbott.

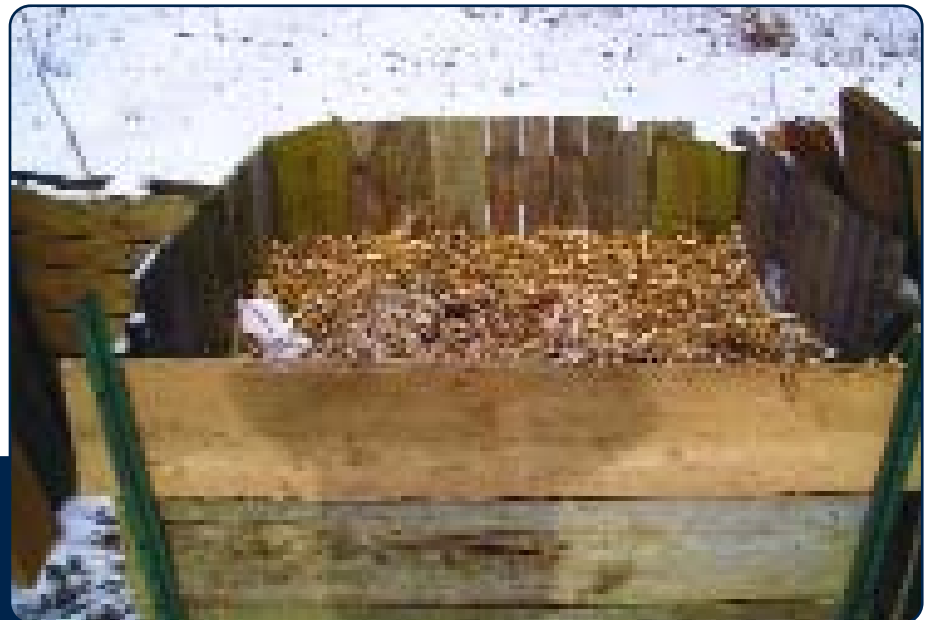
**Bin holding finished toilet compost.** The compost is combined with fresh grass clippings, hay, and mulch and is allowed to secondary compost. Alternate bins allow compost to age for a minimum of two years. Photos by Rich Abbott.

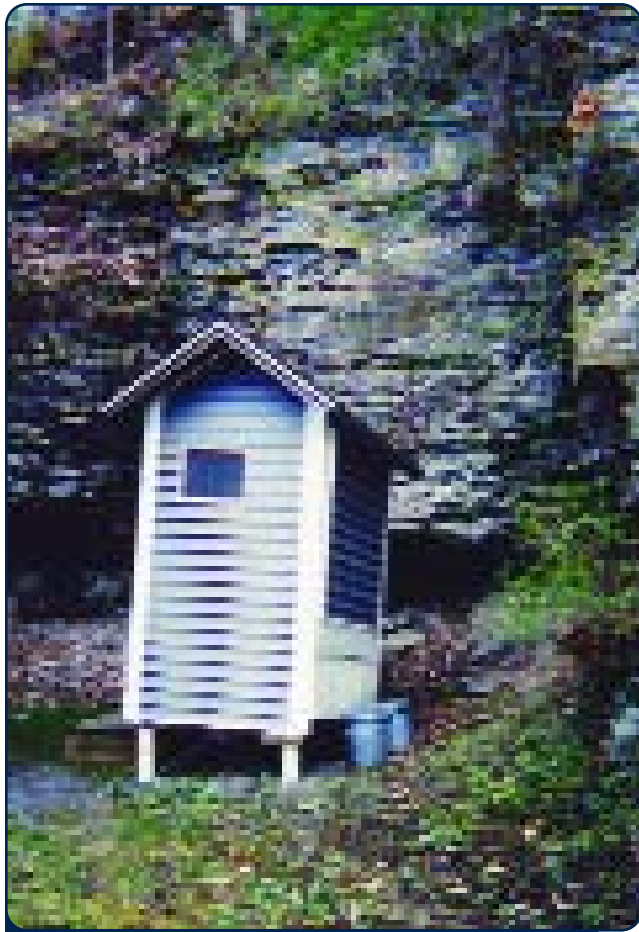
Privy behind a Skaneateles home shows the steep rocky terrain and limited land available for conventional onsite wastewater treatment systems. Photo by Patricia Miller.
